Building & Timber Pest Inspection Report 100 Sample Road Sampleville, VIC 3000

January 1, 2025

Report: 25999

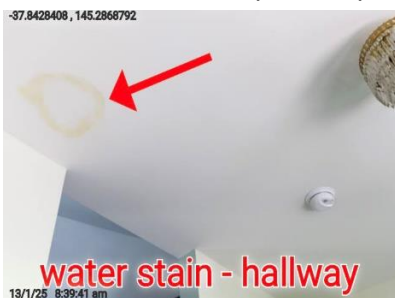
Evidence suggests there is past or present leaks to the ceiling lining within the hallway. No leaks were visible on the day and moisture readings were normal, suggesting that past leaks may have been repaired. However further investigation is recommended to ensure no current leaks exist and to prevent potential structural decay. A licensed builder is required to provide a further assessment and to offer suitable rectification as required.

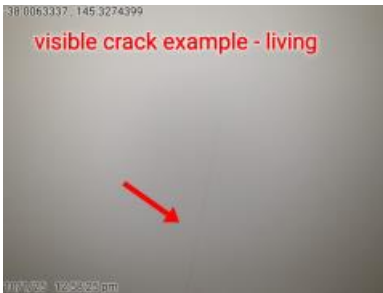
Minor cosmetic settlement cracks were noted to the wall lining within some rooms. Minor cracking can be expected in the type of lining. However, maintenance is required by a suitably qualified plasterer to repair the cracking present.

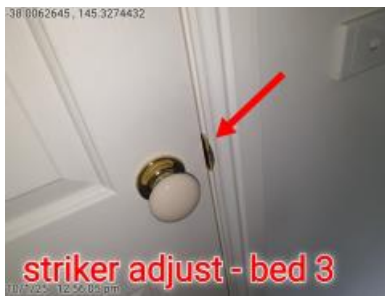
Striker plates to the doors within some rooms need minor adjustment to ensure the doors secure correctly when closed. A licensed carpenter is required to provide a further assessment and to offer suitable rectification as required.

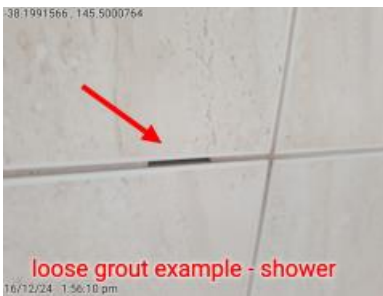
However some minor sections of the grout is loose and/or missing within the shower walls and requires repair by a professional tiler to prevent water penetration and decay to surrounding components.

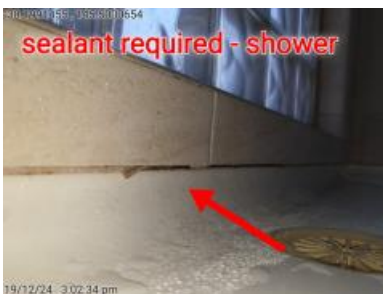
A flexible sealant should be re-installed by a suitably qualified professional to the gaps between tiled walls & base of the shower. This is to prevent water penetration and decay to surrounding components.

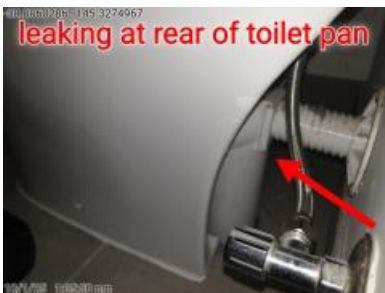
However a leak is present at the rear of the toilet pan and appears to be caused from either a leaking pan/waste seal or cistern leak. This needs to be repaired to prevent decay to surrounding components. A licensed plumber is required to provide a further assessment and to offer suitable rectification as required.

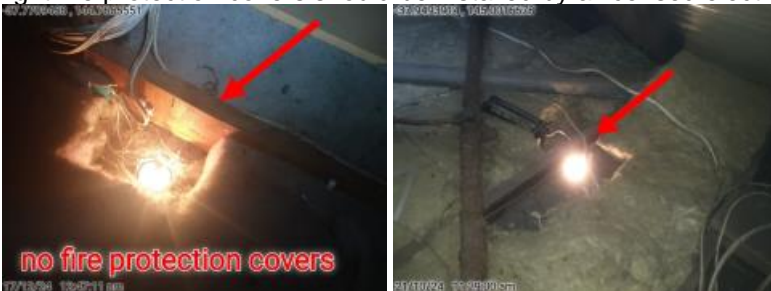
The electrical down lights do not have fire protection covers installed which could present safety / fire issue. Down light fire protection covers should be installed by a licensed electrician as a matter of urgency.

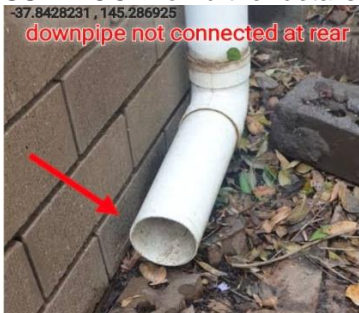
Some downpipes to the rear elevations do not appear to be connected to a stormwater dispersal system. These should be connected without delay to prevent decay to surrounding components and to prevent the foundations of the dwelling being damaged. This also effects the timber pest management of the property and may attract termites. A licensed roof plumber is required to provide a further assessment and to offer suitable rectification as required.

This issue may also be contributing to some damp subfloor conditions - please see section of report under SUBFLOOR for further details.

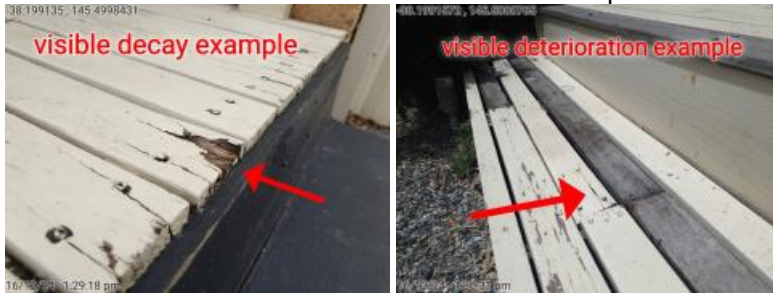
Minor wet rot decay is present to the decking boards where exposed to weather. Decayed timbers need repair or replacement to prevent additional deterioration. A licensed carpenter and/or builder is required to provide a further assessment and to offer suitable rectification as required.

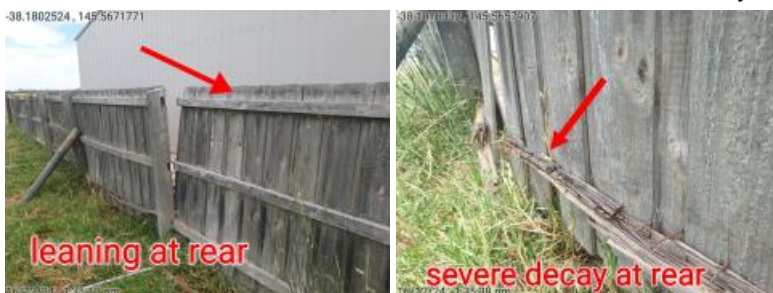
However a section of the fences on the south boundary are generally in poor condition. Severe wet rot decay, and other defects were noted to these timber fences and decayed timber needs replacement by a carpenter.

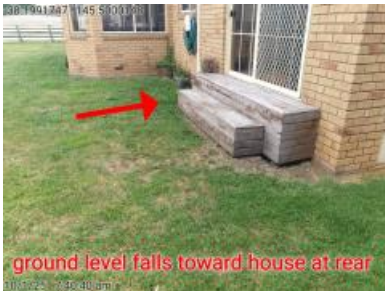
Damp soil was noted in the subfloor to the rear of the dwelling. Ground levels also appear to fall toward the house at the rear, and this appears to be contributing to the damp sub-floor conditions. Therefore the drainage to this area is deemed inadequate. Poor site drainage can create unstable foundations that may have an adverse structural effect on the dwelling. Rectification is required. Ground/paving levels should be altered where possible, and/or drains should be installed to divert seepage and surface runoff water away from the house. The drains should be connected to the existing stormwater drainage system. Please contact a licensed drainer and/or licensed builder to make a further assessment and to offer suitable rectification advice.

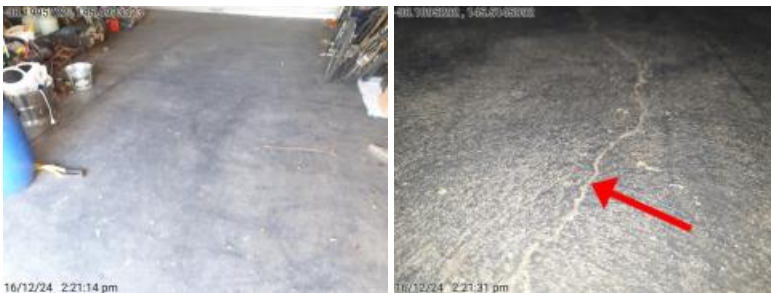
The concrete floor is generally in good condition. However minor cracking was noted. Cracking can be quite common for a concrete floor. Recommend these cracks be monitored for further movement.

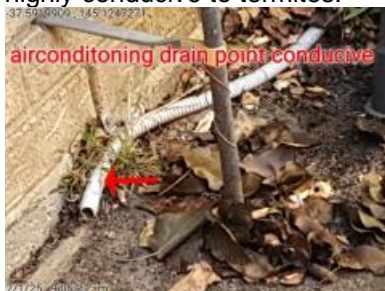
The air-conditioning condenser discharges adjacent to the external walls. We recommend modification so that water is discharged over a drain. Air conditioning units which release water alongside or near to building walls should be piped to a drain (if not possible then several meters away from the building) as the resulting wet area is highly conducive to termites.

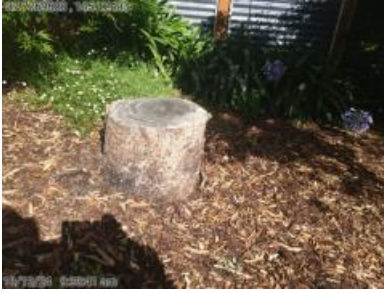
Tree stumps should be removed. This is because tree stumps left over time can be highly attractive to subterranean termites.

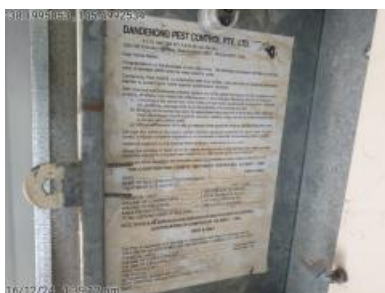
A notice indicates that the property may have been treated in respect to attack by subterranean termites. We strongly recommend any prospective purchaser attempt to verify the full extent of any treatment or other work carried out and obtain copies of all relevant documentation.
