Building & Timber Pest Inspection Report 100 Sample Road Sampleville, VIC 3000

January 1, 2025

Report: 25999

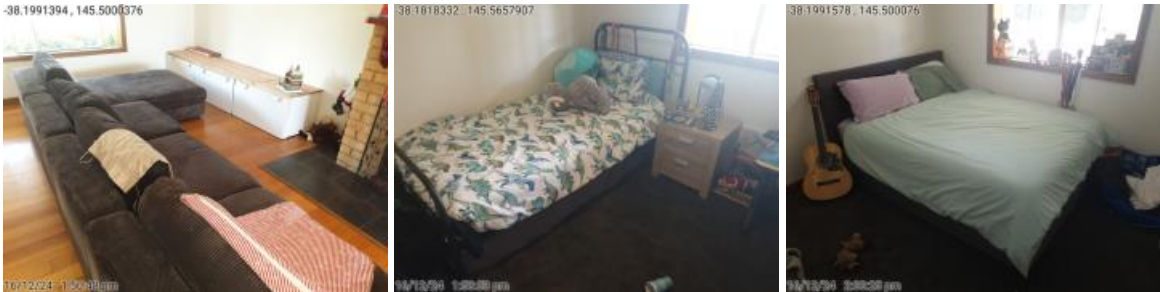
Visual limitations to floors, some walls and the robes were present due to but not limited to existing furnishings and or stored items restricted a complete evaluation of these areas and or components. Defects or timber pest may be present and not identified. Strongly recommend limitations be removed and a re-Inspection be conducted to enable a more complete report to be submitted.

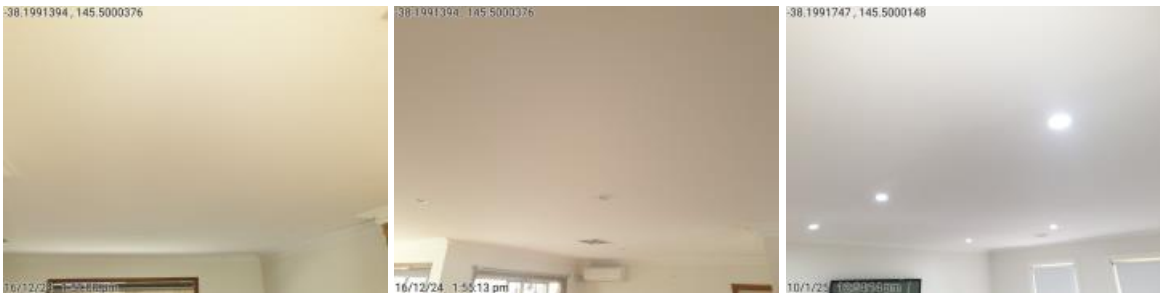
Evidence suggests there is past or present leaks to the ceiling lining within the hallway. No leaks were visible on the day and moisture readings were normal, suggesting that past leaks may have been repaired. However further investigation is recommended to ensure no current leaks exist and to prevent potential structural decay. A licensed builder is required to provide a further assessment and to offer suitable rectification as required.

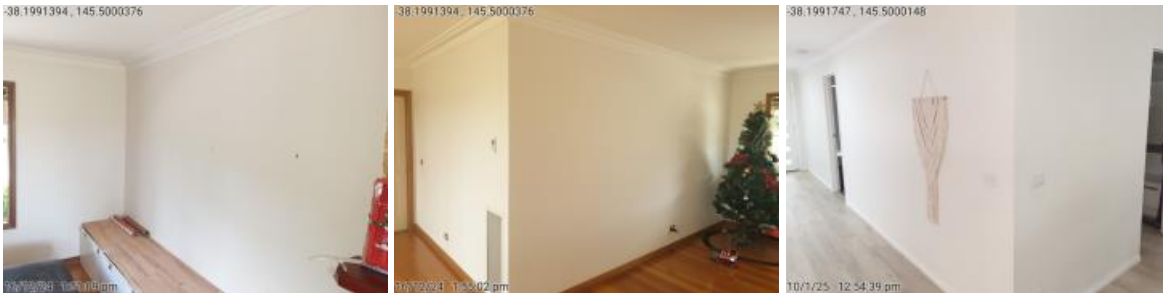
Minor cosmetic settlement cracks were noted to the wall lining within some rooms. Minor cracking can be expected in the type of lining. However, maintenance is required by a suitably qualified plasterer to repair the cracking present.

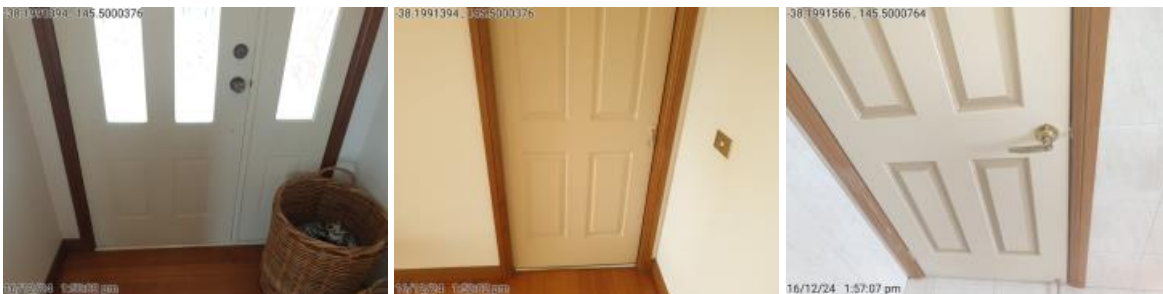
Striker plates to the doors within some rooms need minor adjustment to ensure the doors secure correctly when closed. A licensed carpenter is required to provide a further assessment and to offer suitable rectification as required.

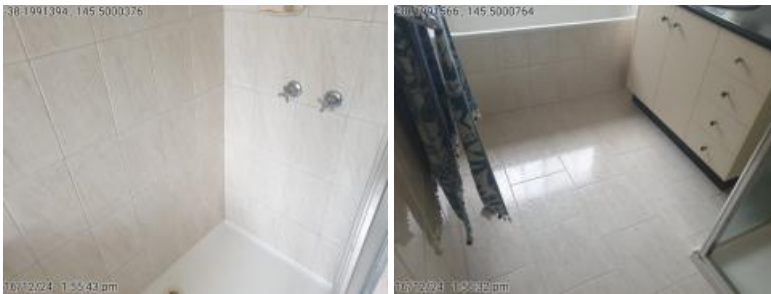
However some minor sections of the grout is loose and/or missing within the shower walls and requires repair by a professional tiler to prevent water penetration and decay to surrounding components.

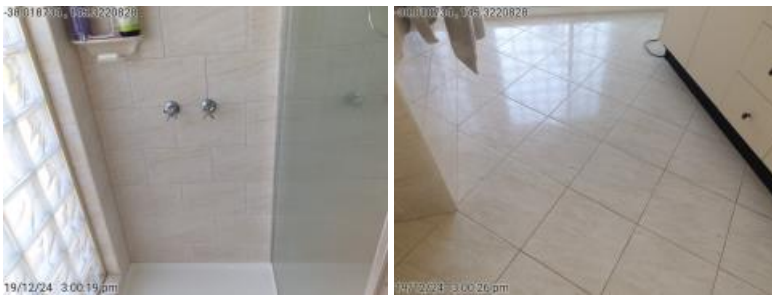
A flexible sealant should be re-installed by a suitably qualified professional to the gaps between tiled walls & base of the shower. This is to prevent water penetration and decay to surrounding components.

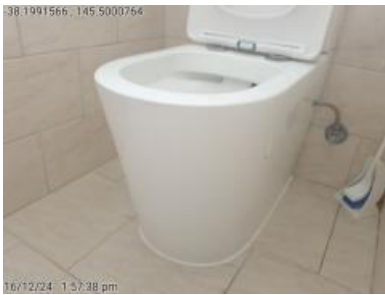
However a leak is present at the rear of the toilet pan and appears to be caused from either a leaking pan/waste seal or cistern leak. This needs to be repaired to prevent decay to surrounding components. A licensed plumber is required to provide a further assessment and to offer suitable rectification as required.

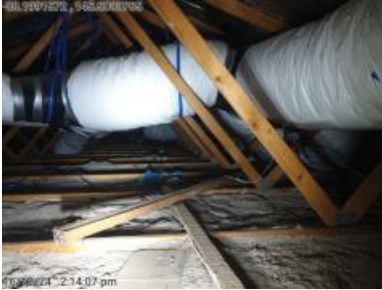
Insulation and ducting is present in the roof cavity. This restricted inspection to some roofing timbers (Including but not limited to: Ceiling joist and top wall plates). Removal of insulation and ducting is not within the scope of a standard visual inspection report however, would be necessary for a more complete report to be submitted. Defects and or timber pest may be present and not detected.

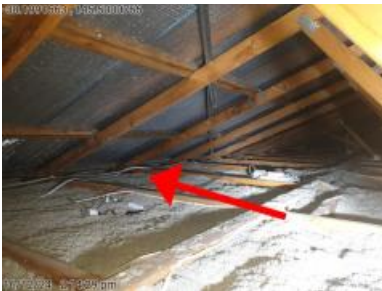
Inspection over the eaves and low areas to the perimeter of the building was restricted due to the low pitch and method of construction allowing only a limited visual inspection from a distance. Items such as top plates and ceiling and roof framing in these areas was not able to be fully inspected. Defects and/or timber pest may be present and not detected.

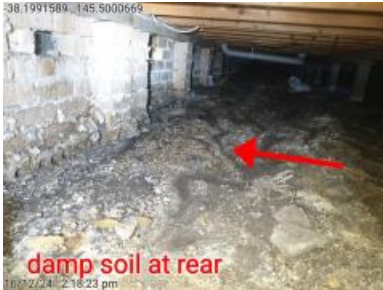
The underfloor soil is damp at the rear of the dwelling. This may be due to a drainage problem or some other factor. Rectification is required, as this dampness may have adverse effects on the foundations and/or cause timber deterioration to the floor frame. Damp soil also creates conditions highly conducive to termite attack and the source of the damp should be further investigated and addressed by a licensed builder or drainage expert to prevent such issues. Please see section of report under "DRAINAGE - SURFACE WATER". for further information regarding this matter.

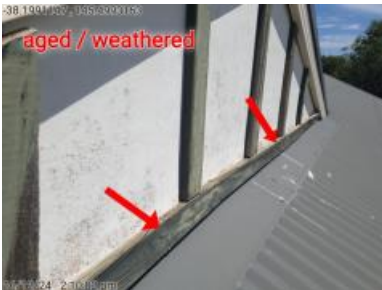
However some of the external wall timbers show signs of age and weathering to the gable trims at the front of the dwelling. Maintenance and/or repairs will be required to prolong the life of the materials and to prevent further deterioration. A licensed carpenter and/or painter is required to provide a further assessment and to offer suitable rectification as required.

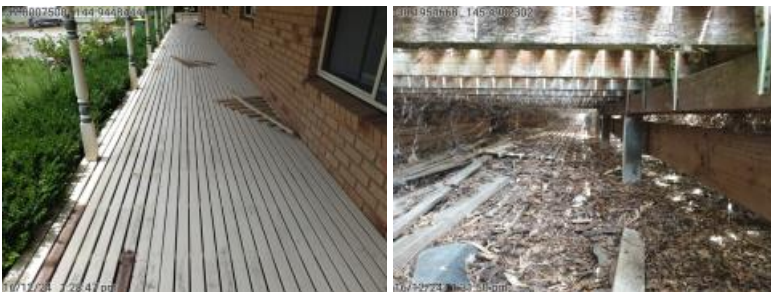
The overall condition of the decking timber and sub-deck support framing that was visible is fair.

Minor wet rot decay is present to the decking boards where exposed to weather. Decayed timbers need repair or replacement to prevent additional deterioration. A licensed carpenter and/or builder is required to provide a further assessment and to offer suitable rectification as required.

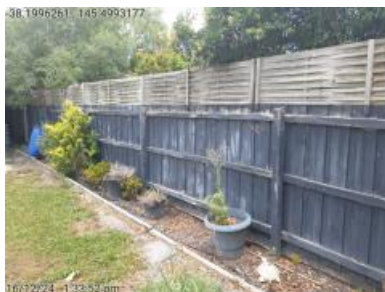
The fences are mainly constructed from timber. The fences are generally in fair condition but some repairs or maintenance is required.

However a section of the fences on the south boundary are generally in poor condition. Severe wet rot decay, and other defects were noted to these timber fences and decayed timber needs replacement by a carpenter.

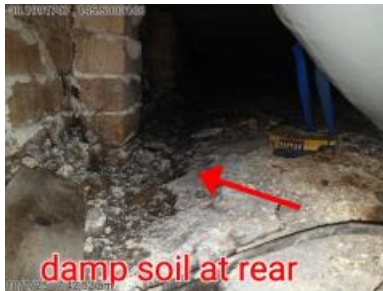
Damp soil was noted in the subfloor to the rear of the dwelling. Ground levels also appear to fall toward the house at the rear, and this appears to be contributing to the damp sub-floor conditions. Therefore the drainage to this area is deemed inadequate. Poor site drainage can create unstable foundations that may have an adverse structural effect on the dwelling. Rectification is required. Ground/paving levels should be altered where possible, and/or drains should be installed to divert seepage and surface runoff water away from the house. The drains should be connected to the existing stormwater drainage system. Please contact a licensed drainer and/or licensed builder to make a further assessment and to offer suitable rectification advice.

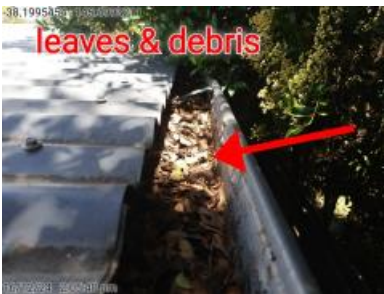
Leaves and debris are present in gutters to the garage. These should be cleared to prolong the life of the guttering material and prevent blockages.

Consideration should be taken to remove the overhanging branches / trees to reduce the amount of debris.

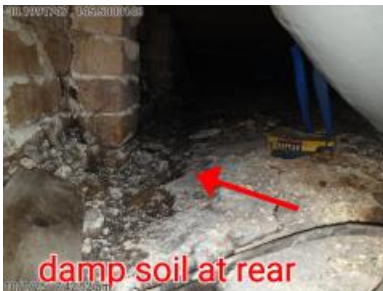
The underfloor soil appears damp at the rear. This should be monitored on a regular basis as moist soil conditions are highly conducive to timber pest attack. Poor drainage, especially in the subfloor, greatly increases the likelihood of wood decay and termite attack. We claim no expertise in plumbing and drainage, however it may be that the drainage is inadequate and in need of improvement.

We recommend the removal of loose timbers from the underfloor area as these predispose the property to termite attack.

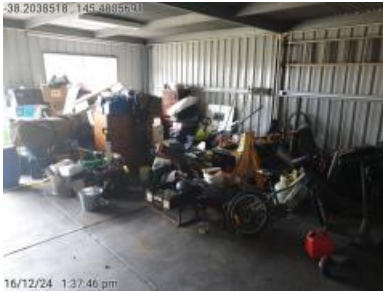
Stored items restricted inspection to the interior. These goods should be removed to enable a more complete report to be submitted. Defects and or timber pest may be present and not detected.

Active termites or other timber damaging pests may be present and not detected in areas where inspection was limited, obstructed or access was not gained. If restrictions or limitations are noted we STRONGLY recommend further access be gained to enable a full inspection of the area(s) prior to making a decision on this property. See Section 2.0 - Reasonable Access.
